Case Study

USA Paper Mill

Repair of Rubber Conveyor Belt

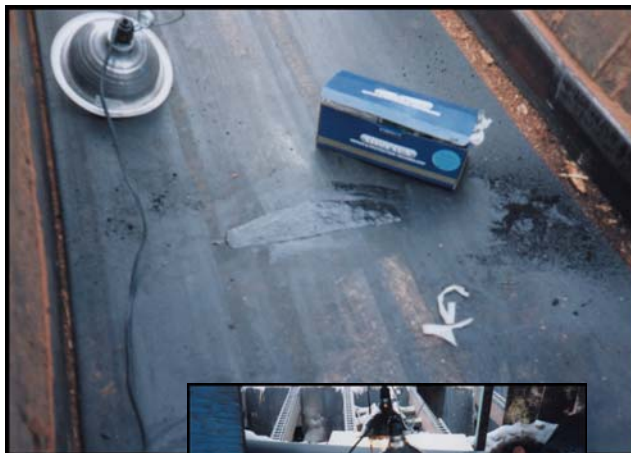
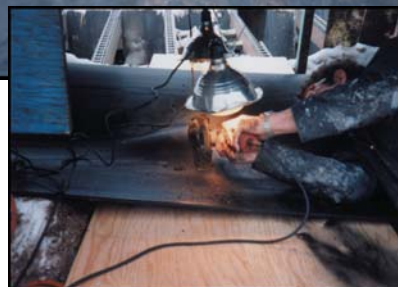
This conveyor belt was used for transporting wood chips from one part of the plywood mill to another.

The conveyor belt had ripped partly due to the sub-zero temperatures which it very often had to operate in and also due to general wear and tear.

A grinder was used to roughen and clean the surface of the belt.

Scotchkote Urethane Elastomer 60RG 537 was used to repair the damaged belt with heat lamps being utilised to keep the affected areas warm and accelerate the cure of the belt
